# Recovery of Fractured Abutment Screw from Implant Body: A Case Report

**Keywords:** Dental implant; fractured abutment screw; screw retrieval kit.

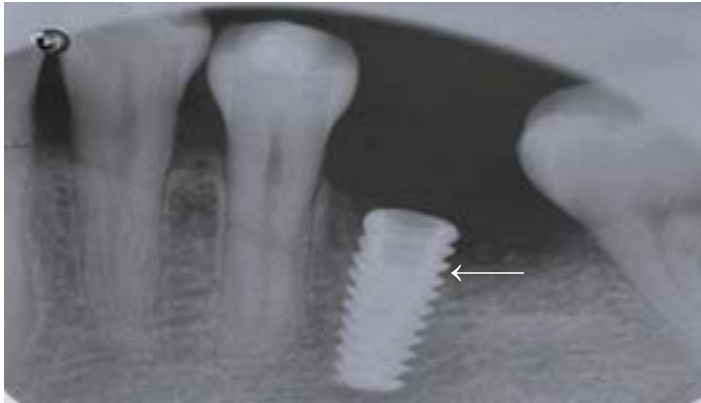
the lower left back region of the jaw for five and a half months. After four months of healing, second-stage implant surgery was performed. On the day of the prosthesis delivery during the tightening of the abutment screw it got fractured and remained within the implant body. Due to some technical error in the first prosthesis, it was a repeat prosthesis on the same final abutment. The abutment screw got fractured after adjustment of the prosthesis during tightening with finger pressure before using the torque wrench. The patient was informed about the fracture and the retrieval of retained screw fragment was planned with verbal consent from the patient followed by replacement with a new abutment and abutment screw. Further radiographic assessment confirmed the presence of the fractured abutment screw threaded into the implant with no indication of any damage to the implant body (Figure 1).

**Figure 1: Radiograph showing fracture part of abutment screw within the implant body.**

Abutment screw fracture in implant-supported restoration is challenging. For the implant to operate effectively, the fractured abutment screw must be removed without endangering the implant body's internal threads. Such fracture may occur due to unobserved screw loosening, overloading, metal fatigue, bruxism, unfavourable design and shape of superstructure, malocclusion and repeated loosening and retightening of screw.<sup>4</sup> Although, the above are the common causes of abutment screw fracture however in this case, surprisingly it fractured on finger pressure which is a novel occurrence. Manufacturers do not specify a torque requirement for healing abutments, impression posts, or cover screws, but final abutments must typically be torqued down to a depth of 20 to 32 Ncm. According to Kanawati et al. in their study, 50 subjects had an average maximum torque ability of 24 Ncm (male dentists: 28 Ncm; students: 22 Ncm; male students: 24 Ncm; female students: 19 Ncm). Maximum torque values for all participants ranged from 11 Ncm to 38 Ncm.<sup>5</sup> Above study verified the study of Goheen et al.<sup>6</sup> and Hill et al.<sup>7</sup> that a wide range of torque force can be delivered with hand screwdrivers. The same final abutment with a screw was sent to a dental prosthetic laboratory for the second time to fabricate a new

crown. There might have been repeated tightening and loosening of the screw which could have caused permanent deformation and lead to screw fracture. According to Kim et al., as the number of tightening and loosening of the abutment screw was increased, the wear or distortion with deformation was more severely progressed.<sup>8</sup>

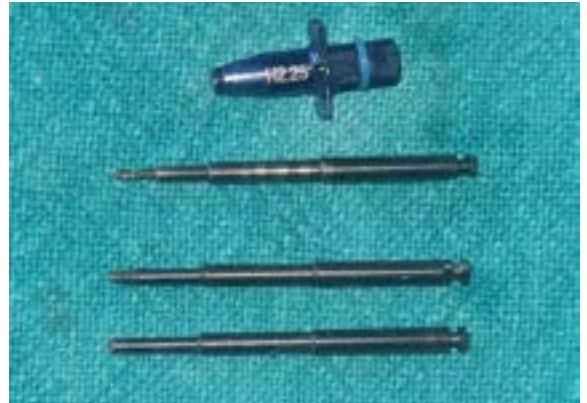
To retrieve the broken fragment, after confirming the site of the fractured screw, the implant body was meticulously cleaned using an air/water spray from the three-way syringe and dried with air. Initially, an explorer or probe was used in a counterclockwise direction to loosen the fragment but it failed. Secondly, we tried with a piezo ultrasonic scaler tip, but that manoeuvre also failed. Since the fractured screw was deep and unable to remove via all the mentioned measures, a screw retrieval kit of i-Fix<sup>®</sup> was used. It contained a drill guide, screw removal drill, screw removal tap, and screw removal bar (Figure 2).

**Figure 2: Screw retrieval armamentarium of the kit.**

At first, a drill guide was inserted into the implant platform. A contra angle handpiece and a screw removal drill at 1,000-1,250 rpm in a push motion/action was used with abundant irrigation to create a hole of 1-2 mm depth into the fragmented screw head. After that, the metal shavings were vacuumed out and the area was irrigated. The tap drill was used to remove the fractured screw from the screw chamber at a speed of 70-80 rpm in counterclockwise motion.<sup>3</sup> Finally, the fractured screw

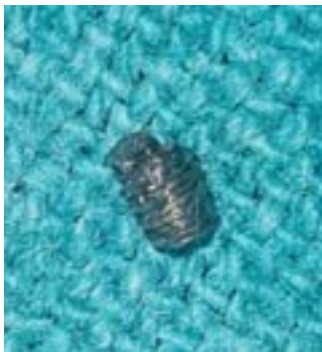
**Figure 3: Retrieved abutment screw.**

was retrieved (Figures 3, 4).

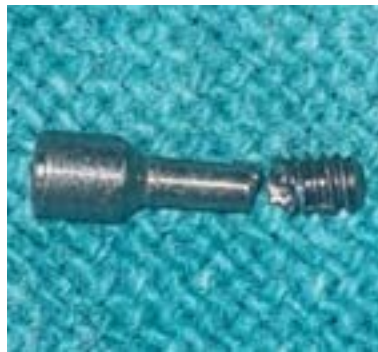
**Figure 4: Fractured part with its upper part.**

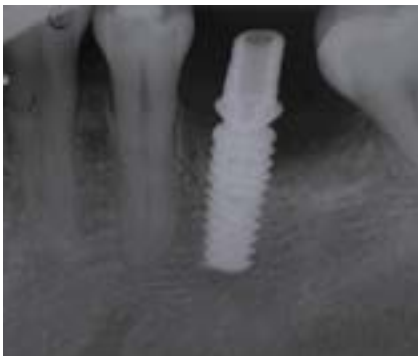
**Figure 6: Checking for the fit of new abutment.**

A radiograph was taken after retrieval of the broken piece (Figure 5). After that, a new abutment and screw was tested for implant fit. The passive fit of the abutment confirmed the preservation of implant's internal structure. The new abutment was secured to the implant body with a screw, the previous prosthesis was cemented, and a radiograph was taken (Figures 6, 7).

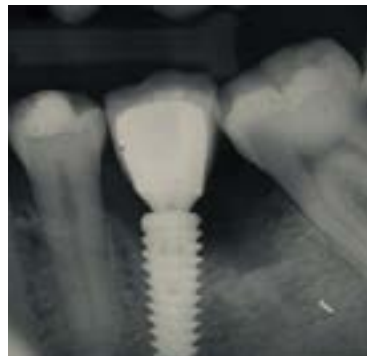
**Figure 7: Radiograph after prosthesis placement.**

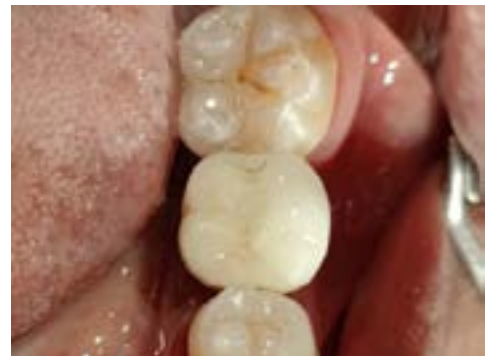
**Figure 8: Clinical view after placement.**
